Loureiro Engineering Associates, Inc.

August 13, 2010

**RE: Hazardous Building Materials Assessment
0 & 39 Cherry Street, 177 & 215 Cherry Avenue, Waterbury, Connecticut
LEA Comm. No. 91WR002.001**

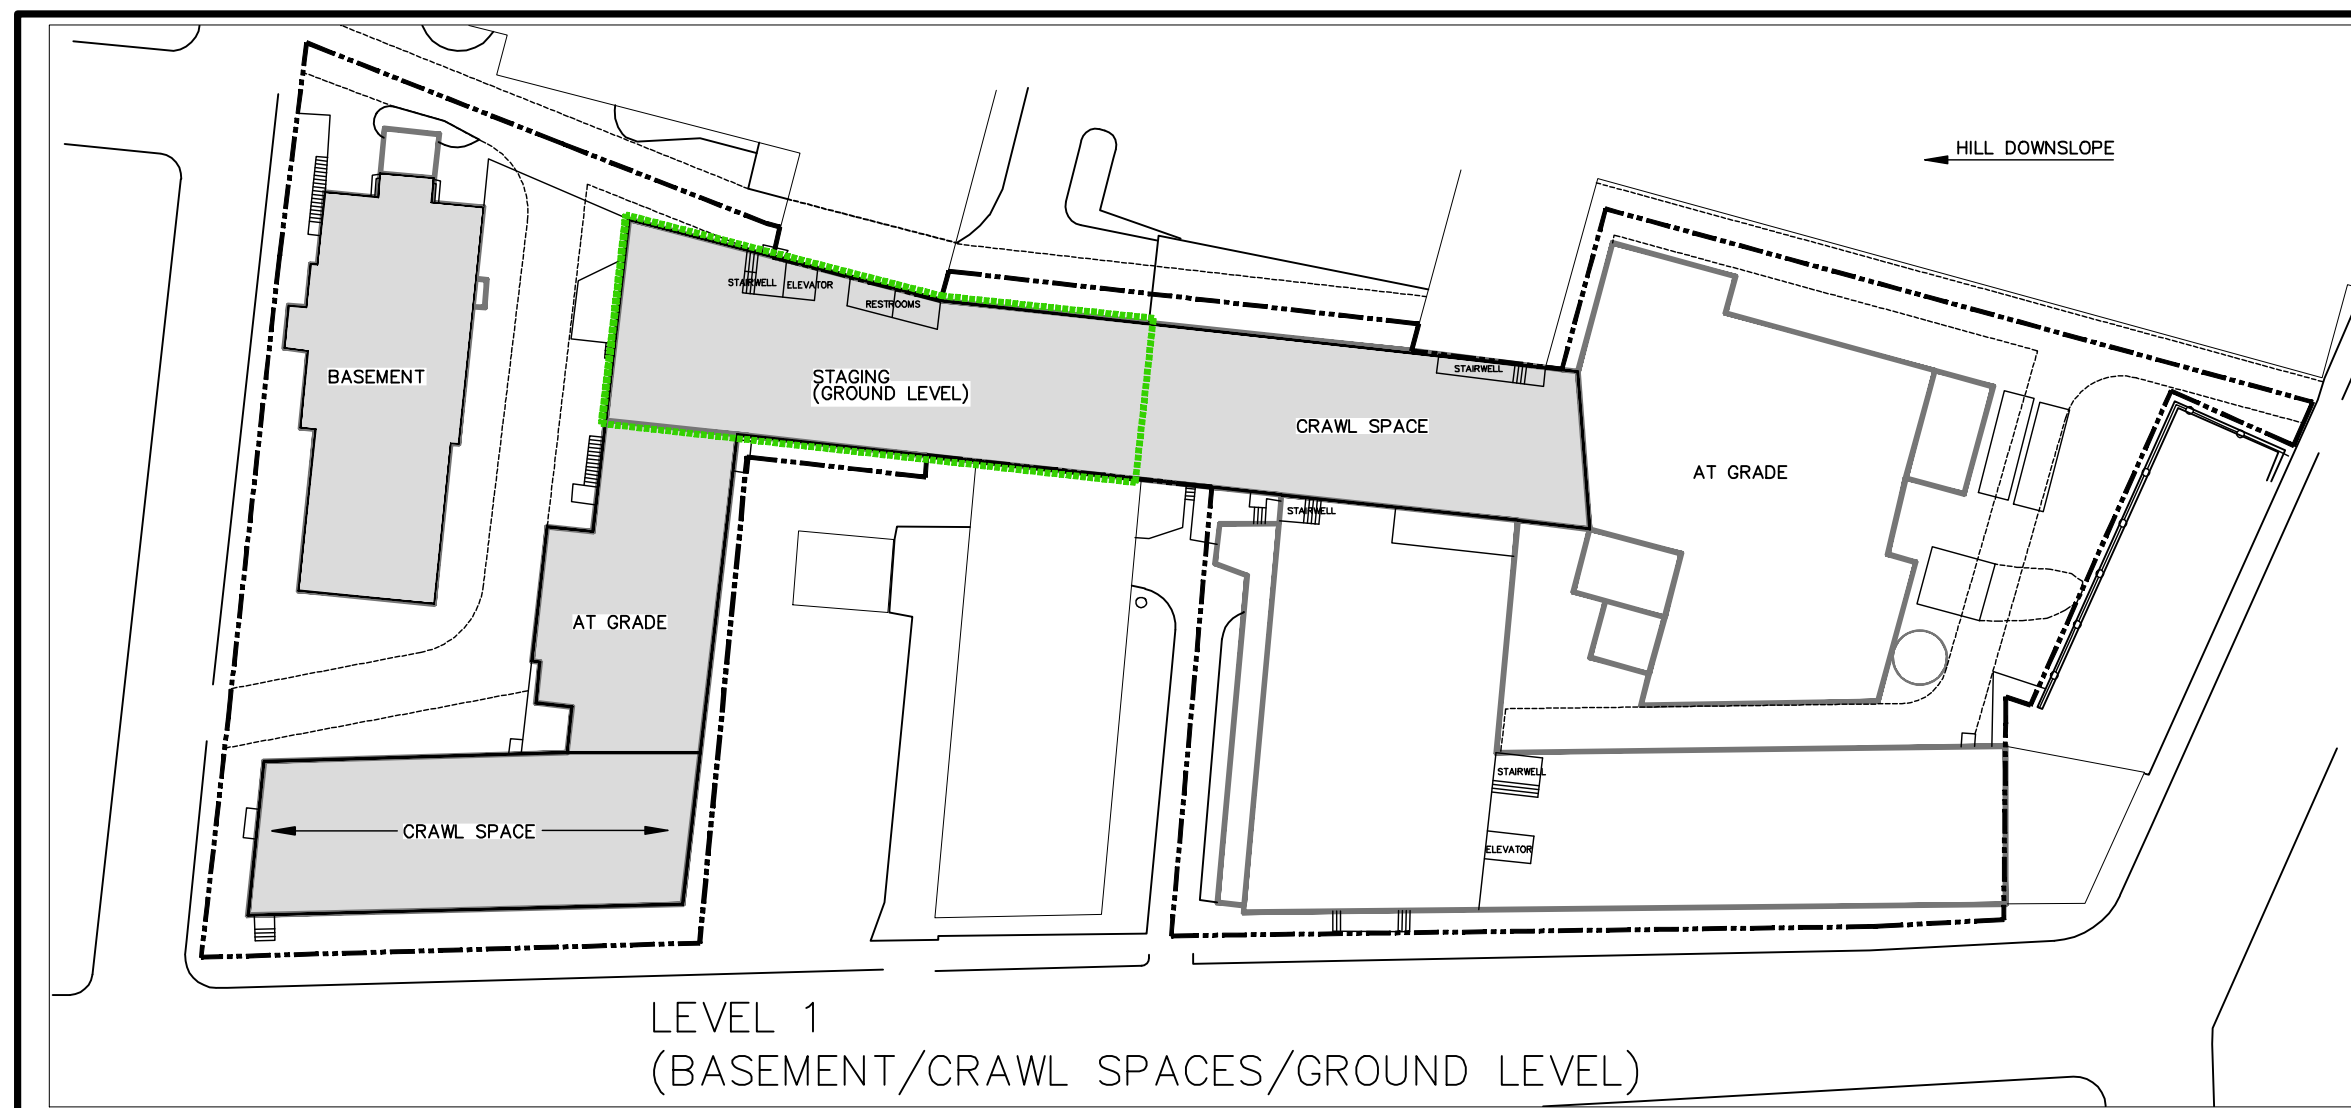
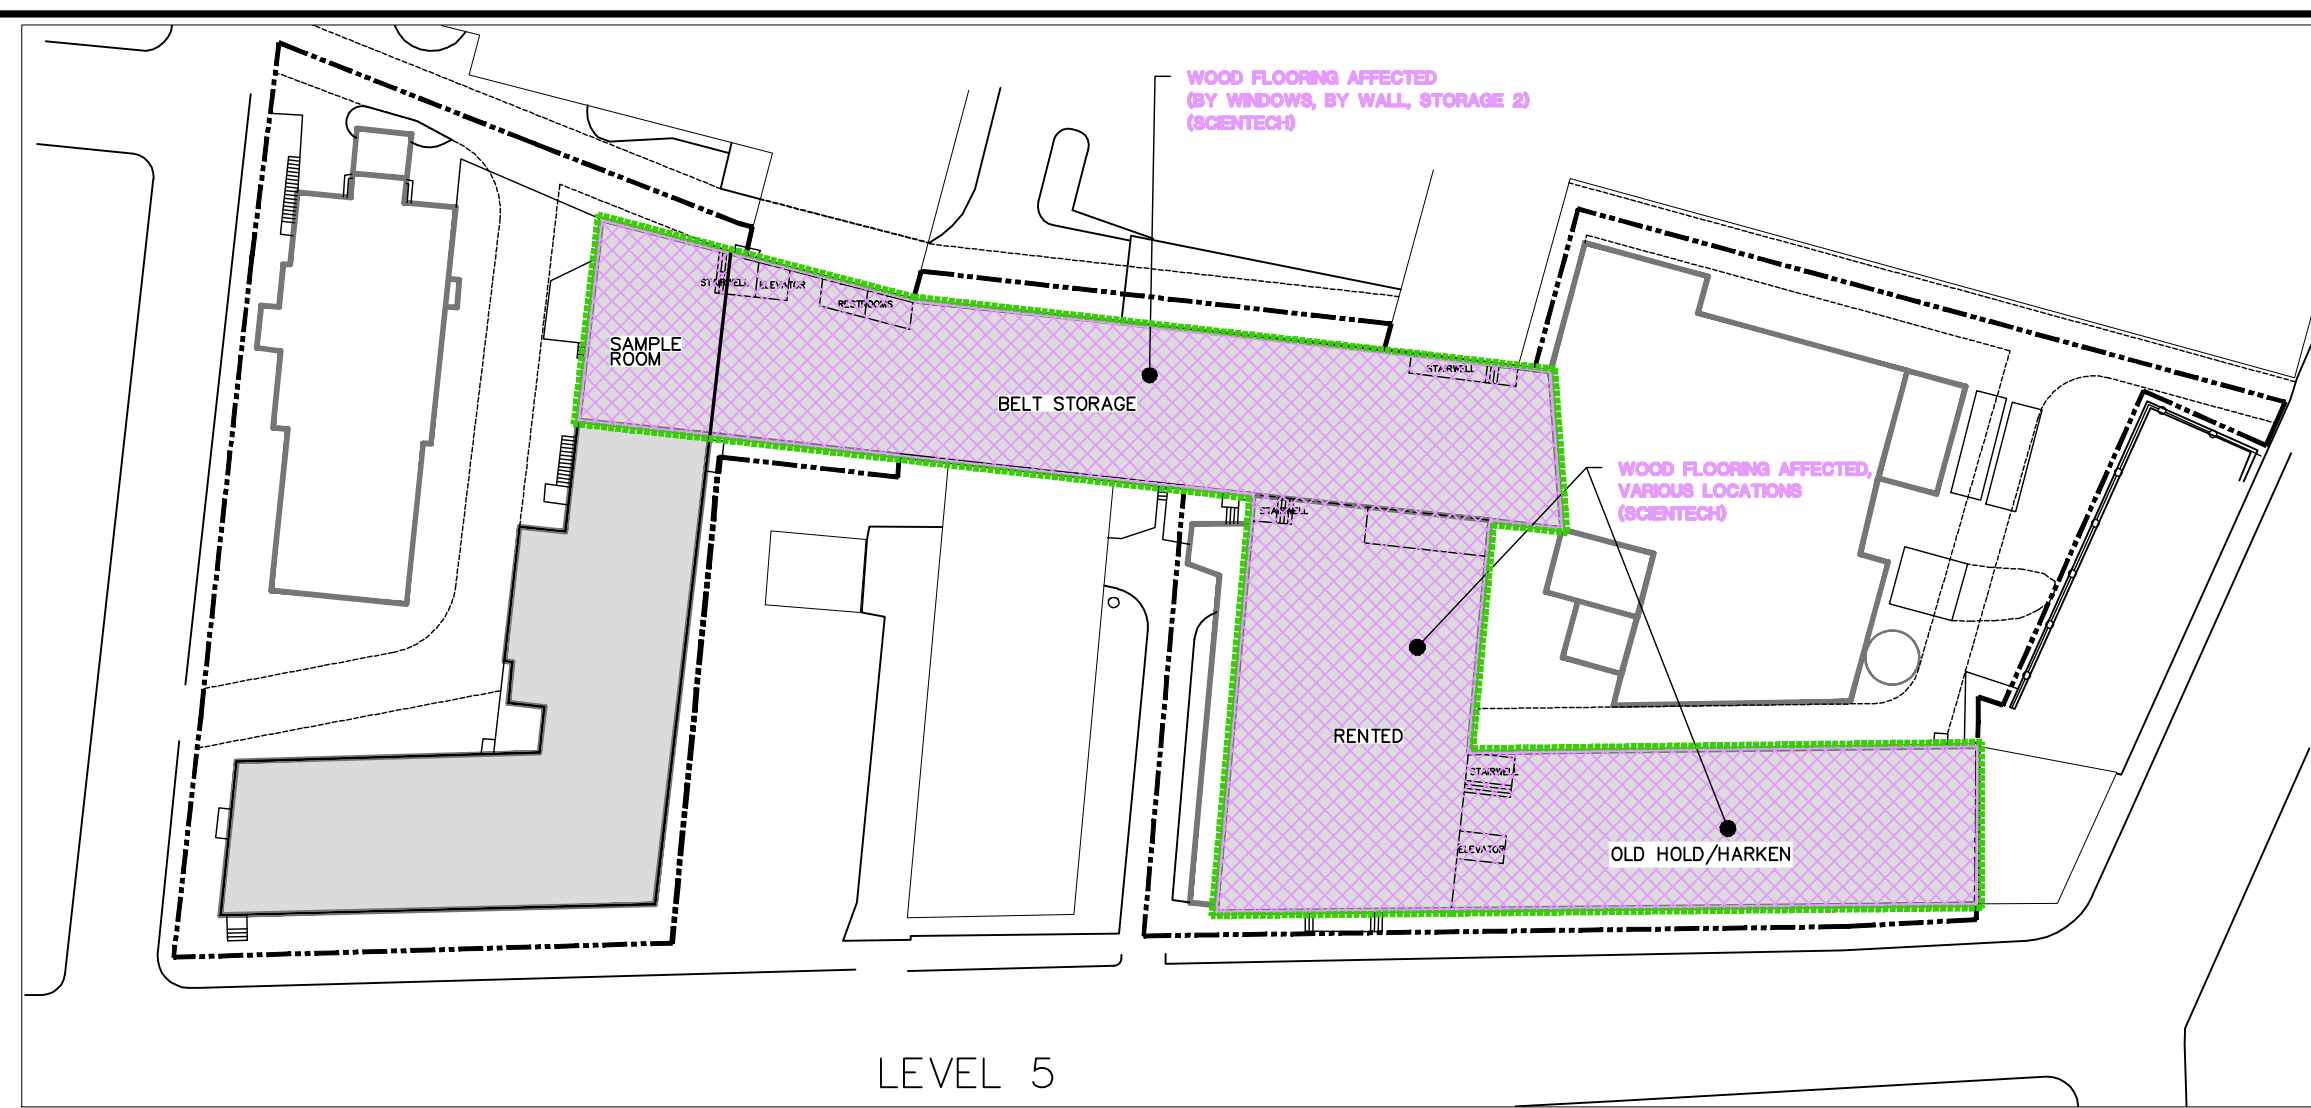
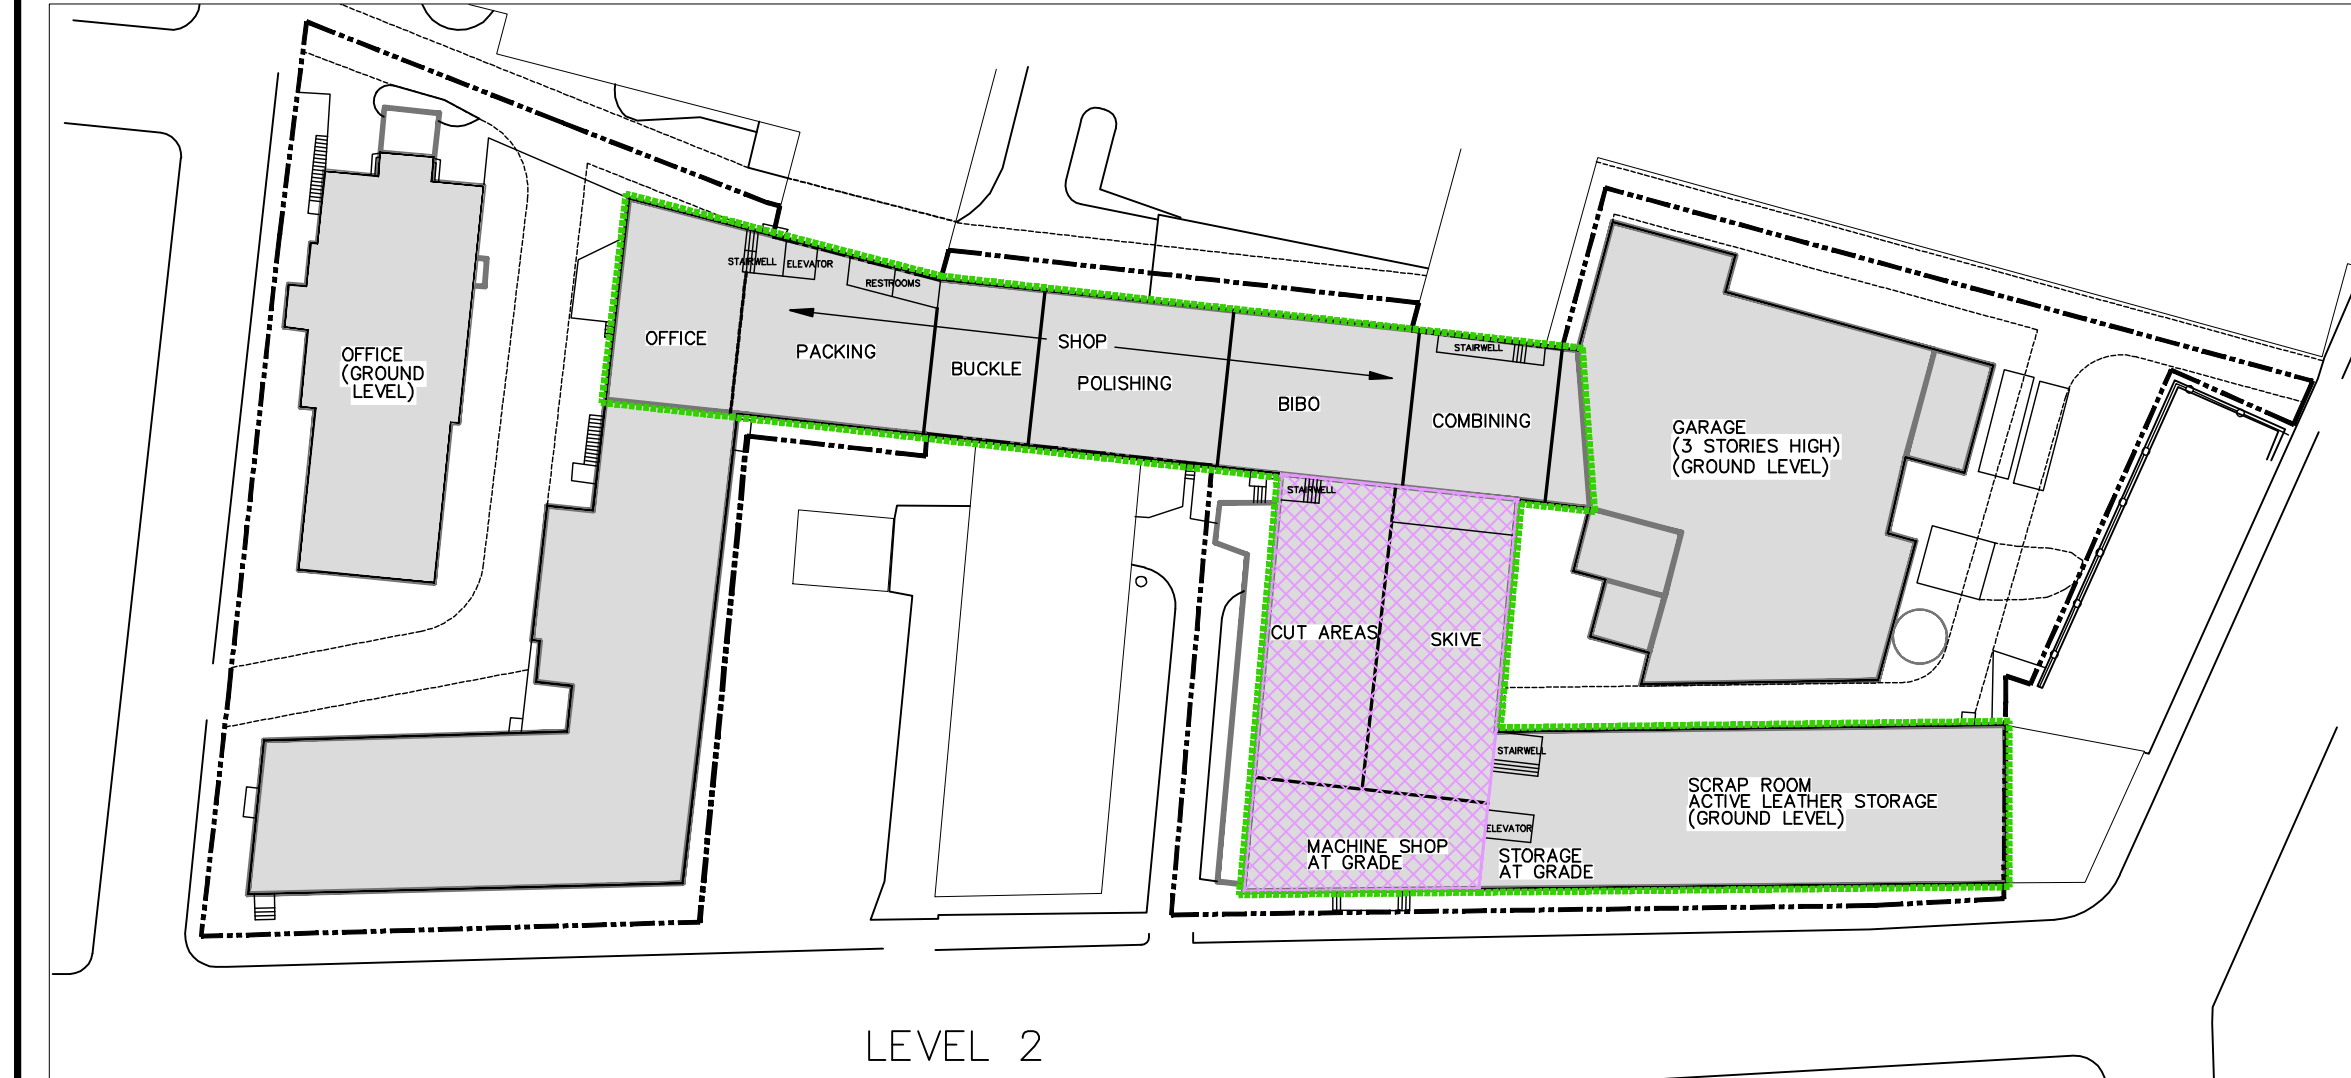
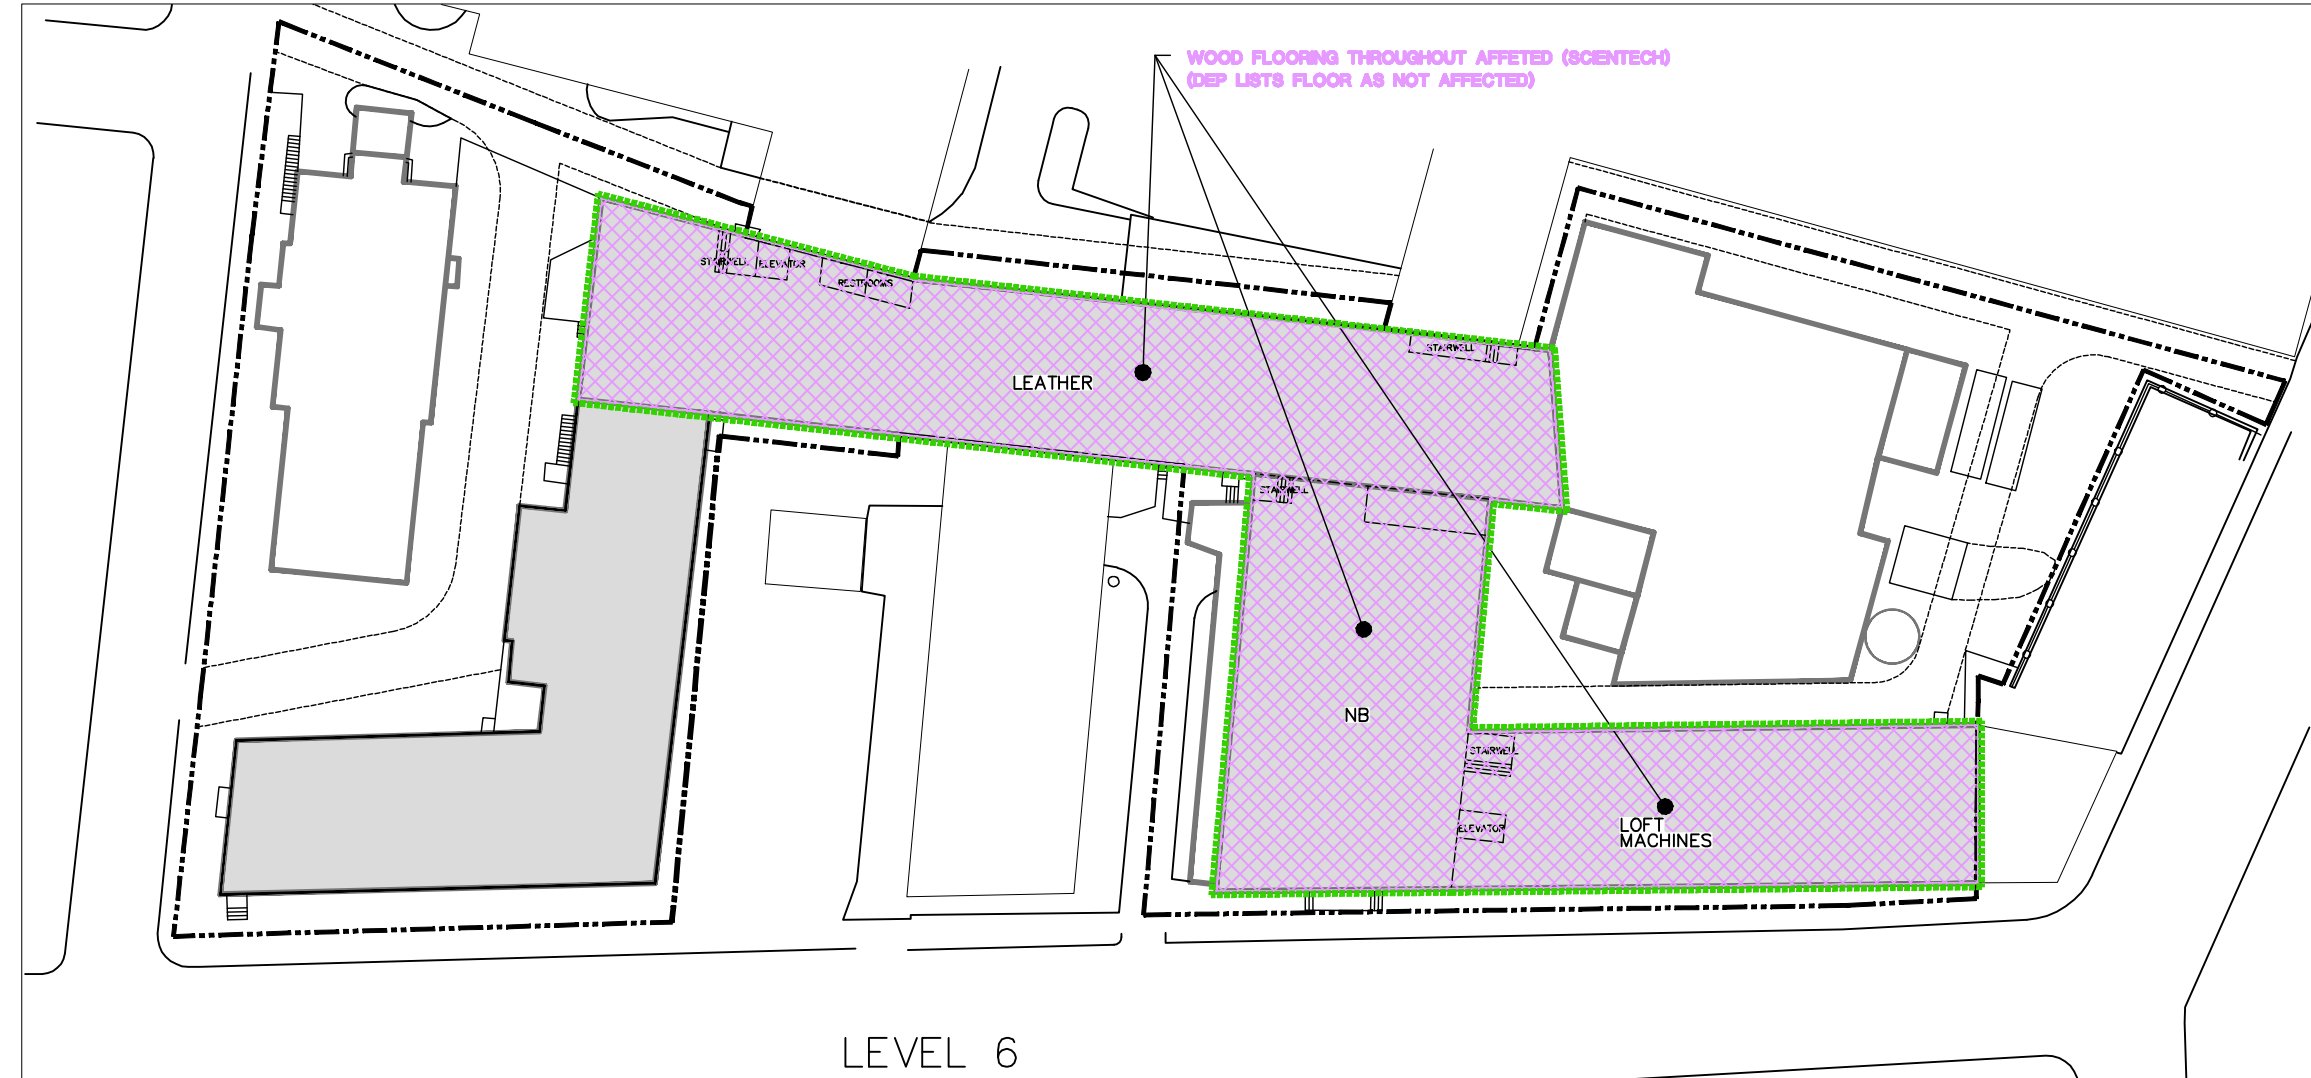
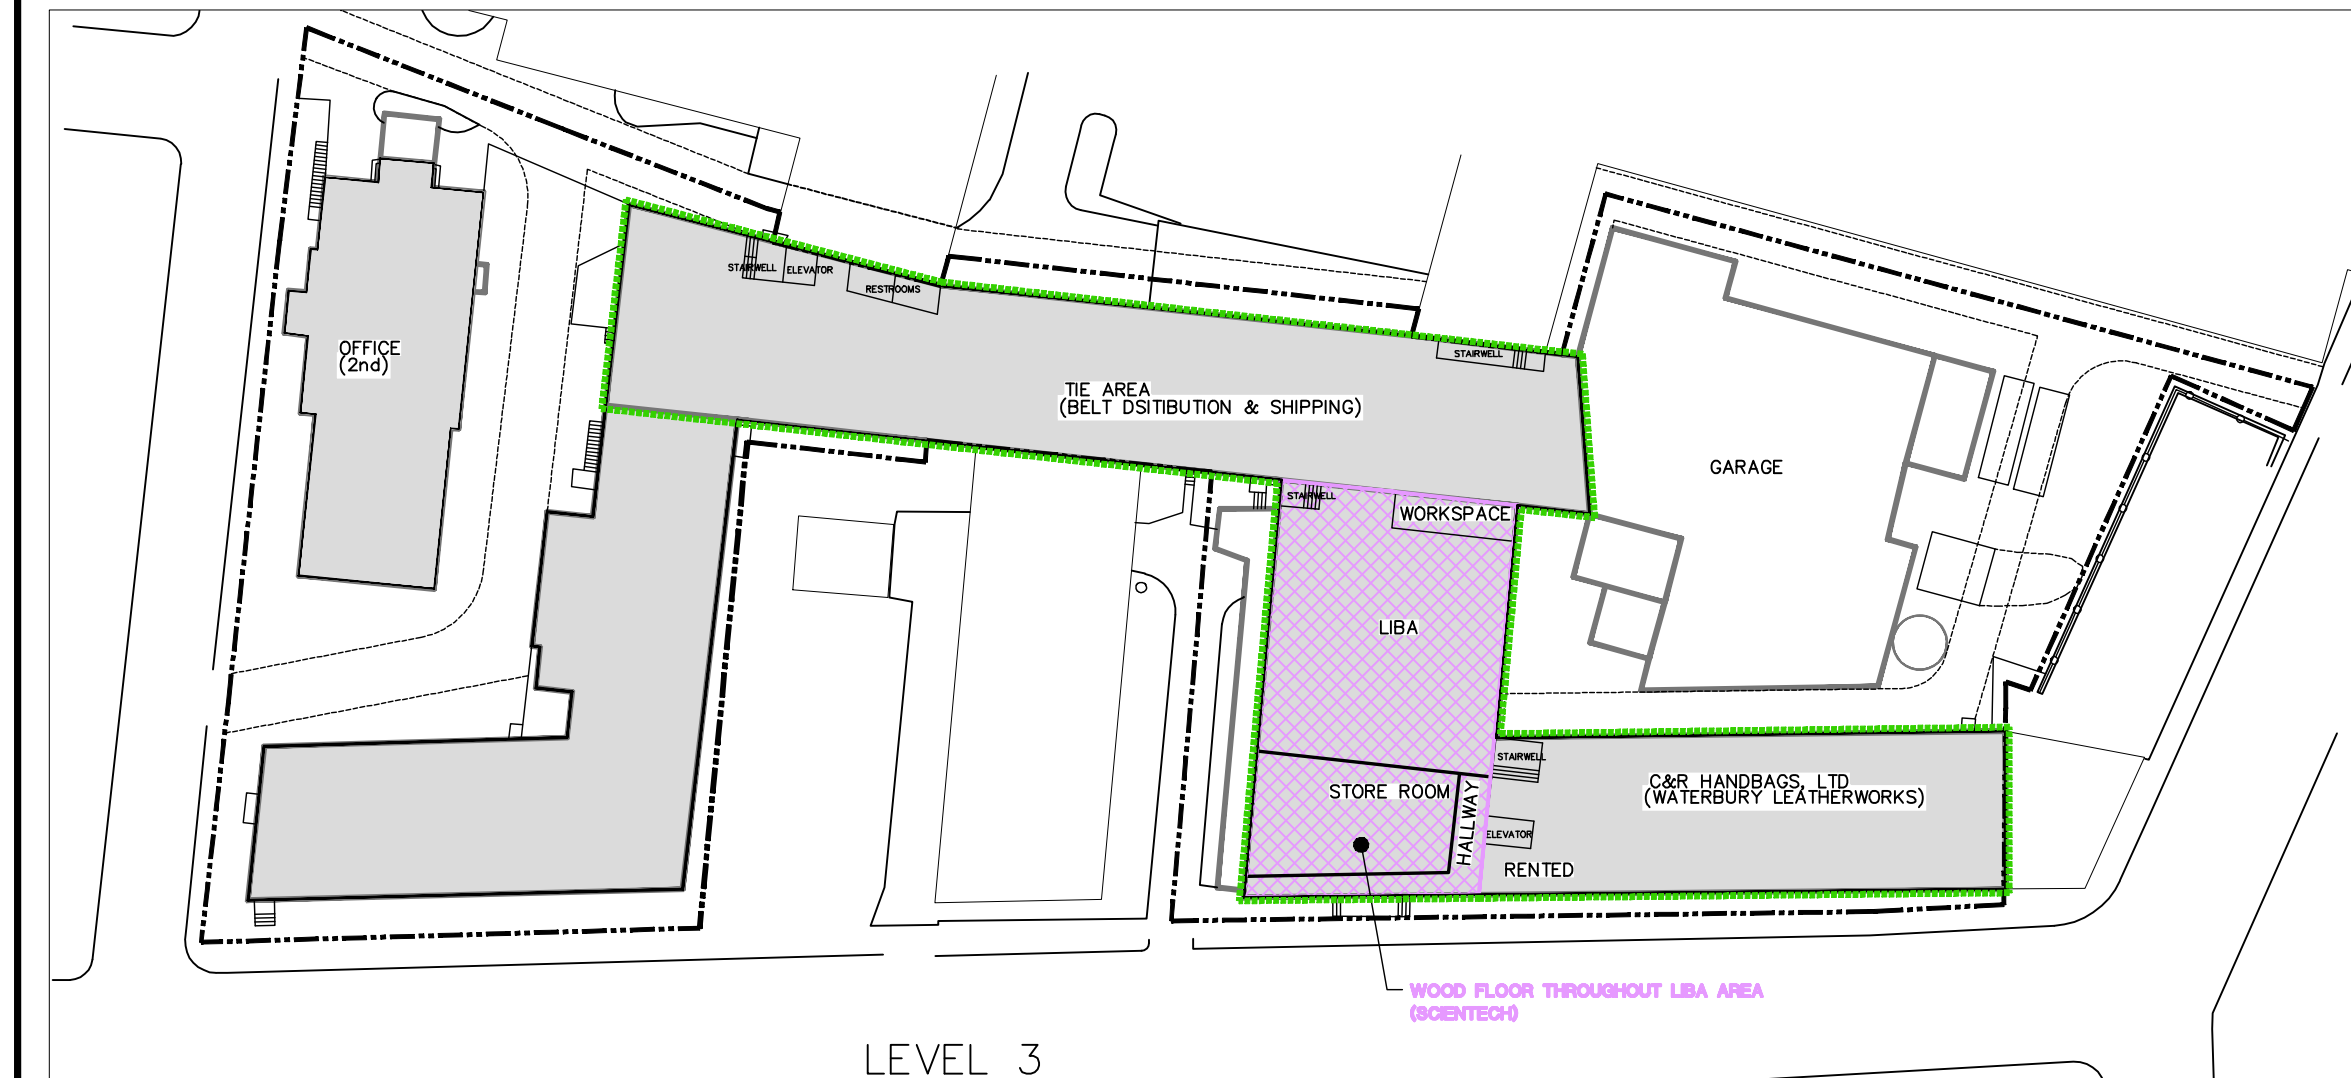
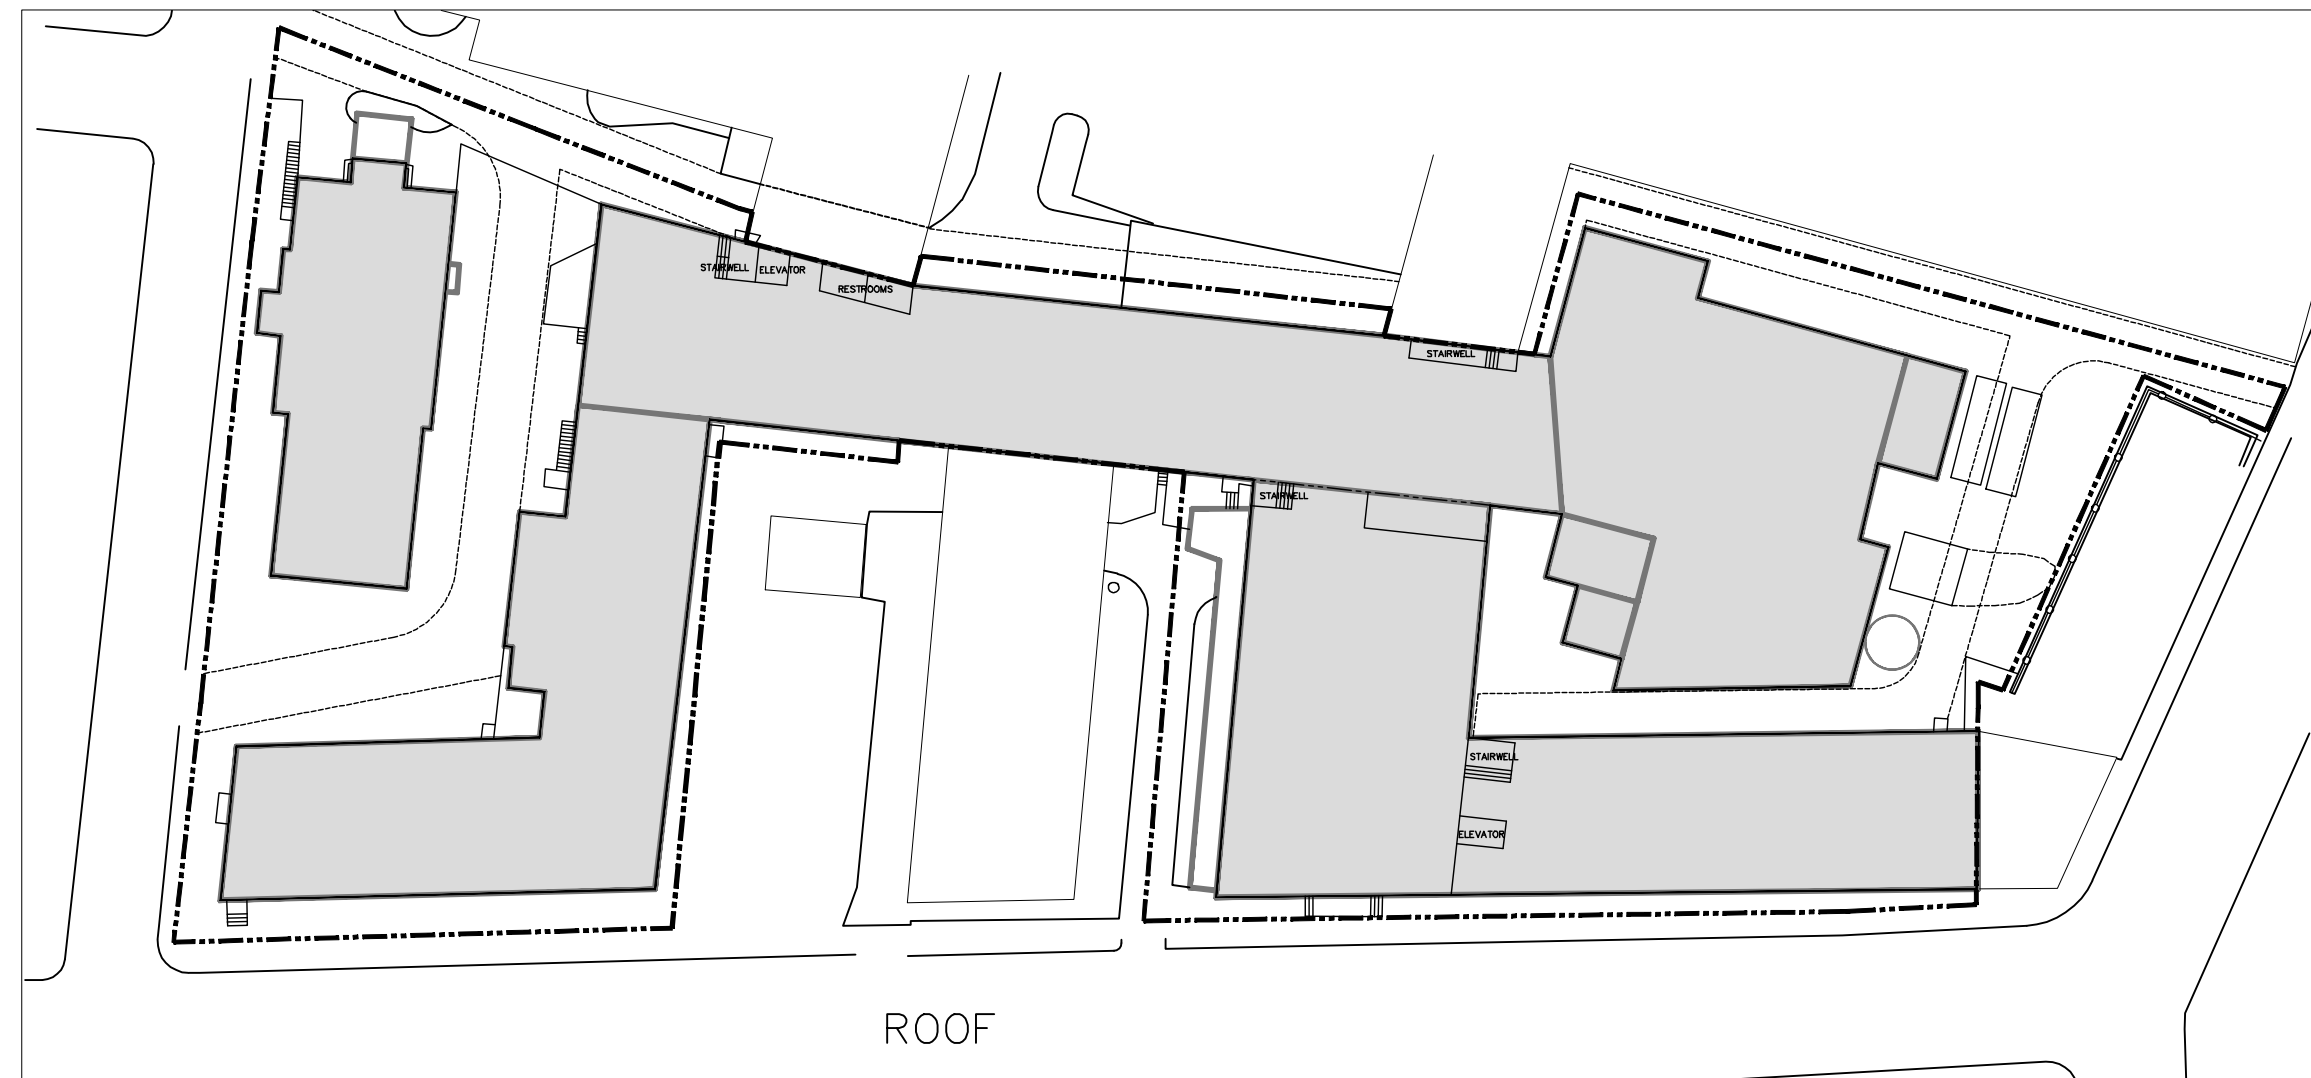
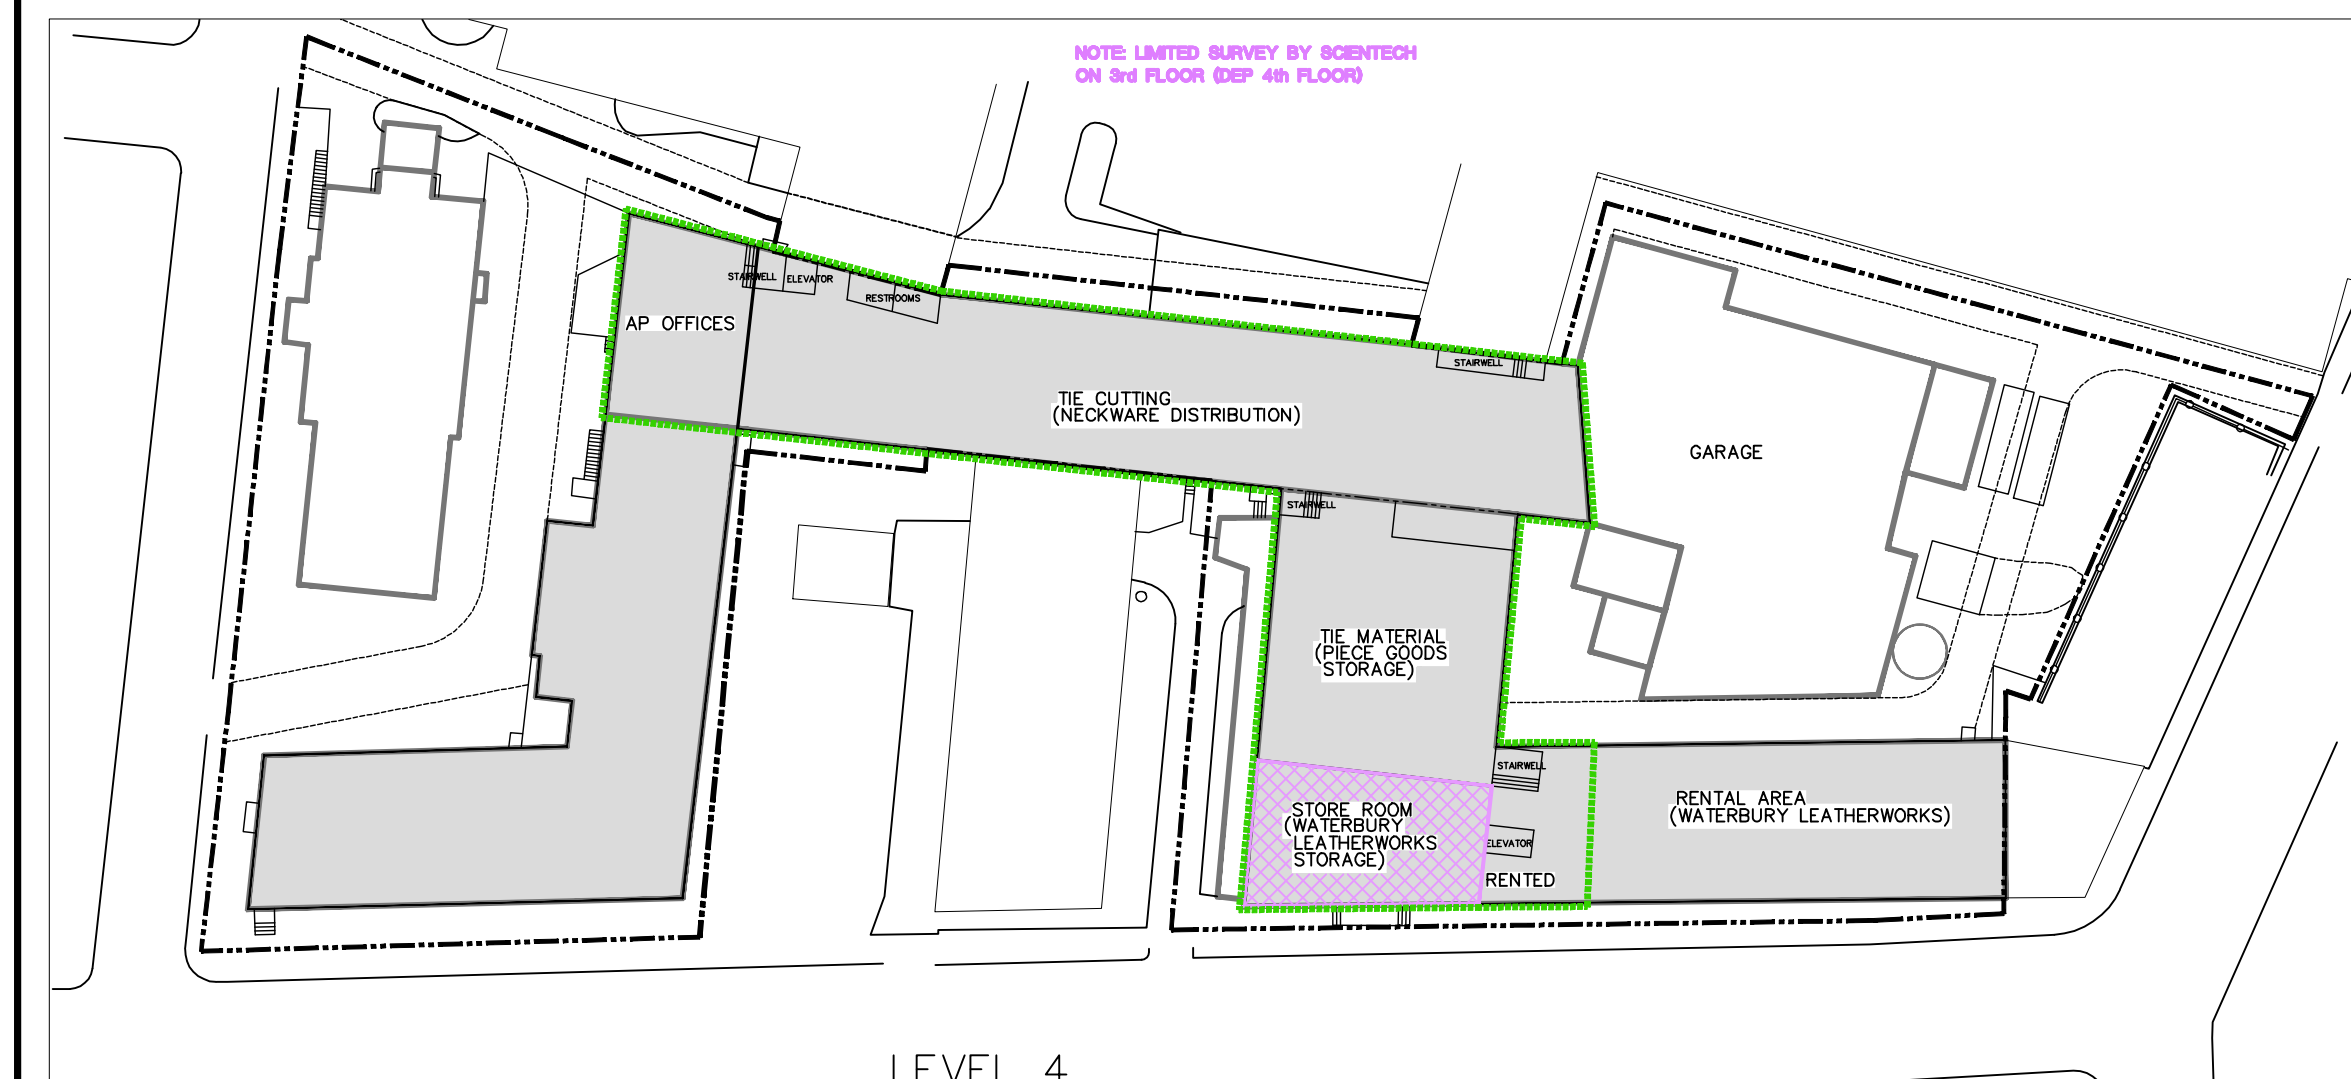
DRAWING

The attached drawing, Drawing 1, depicts generalized areas of known radium contamination in purple hatching; these areas were identified based on written or photographic evidence of radium contamination noted in previous radium survey data and reports. This data was compiled to provide a general understanding of the locations of radium contamination and potential radium for the purposes of health and safety and

At the request of CTDEP, no building material samples were collected from areas known to be subject to radium contamination, as noted from survey data on the attached drawing. The locations of radium-contaminated areas were confirmed by field screening with a Ludlum Model 3 Geiger Counter with a GM 44-9 Pancake Probe. Because sampling was prohibited in these areas, the location and quantities of hazardous buildings materials in these areas were visually assessed and estimated for the purpose of this survey.
