Loureiro Engineering Associates, Inc.

August 13, 2010

**RE: Hazardous Building Materials Assessment
0 & 39 Cherry Street, 177 & 215 Cherry Avenue, Waterbury, Connecticut
LEA Comm. No. 91WR002.001**

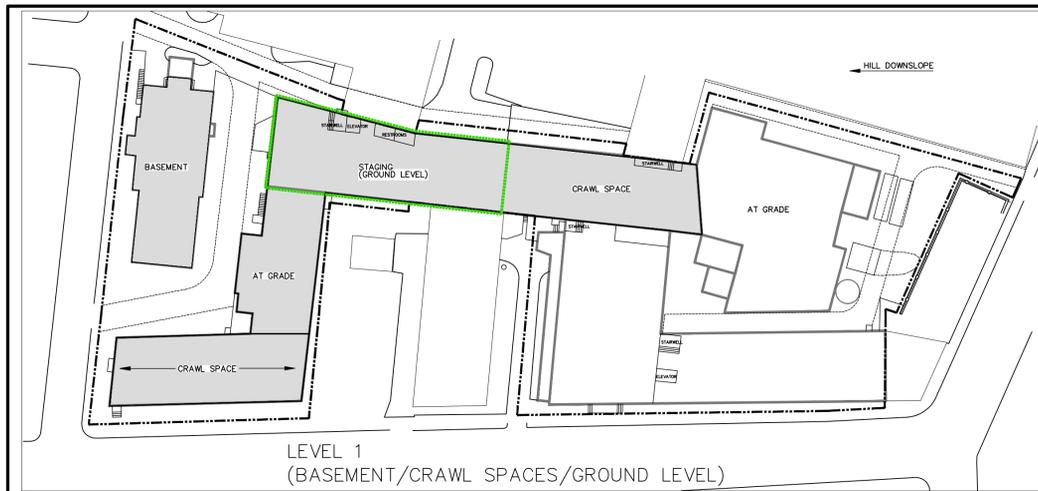
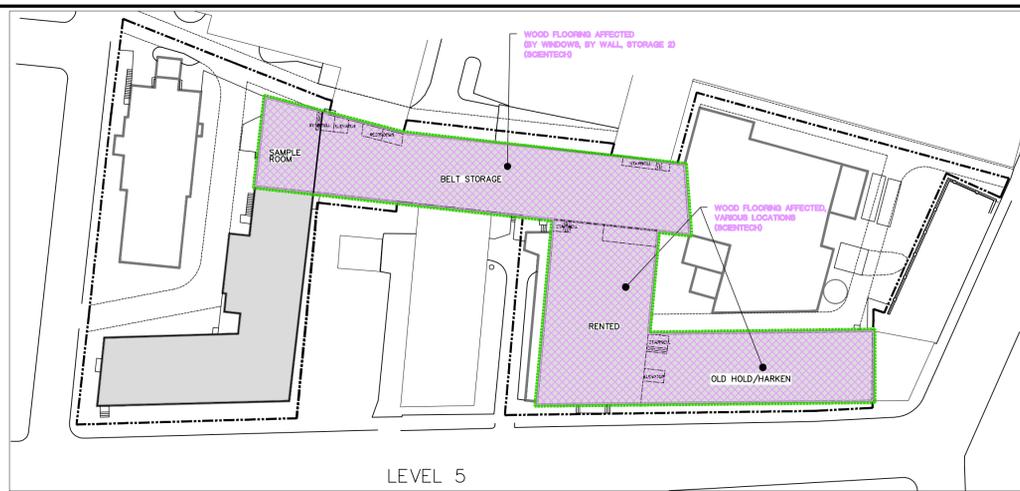
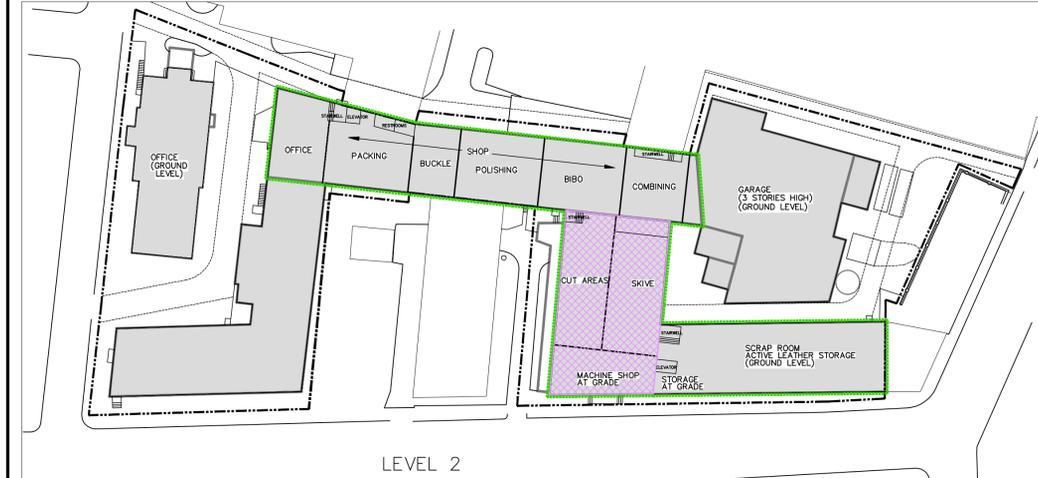
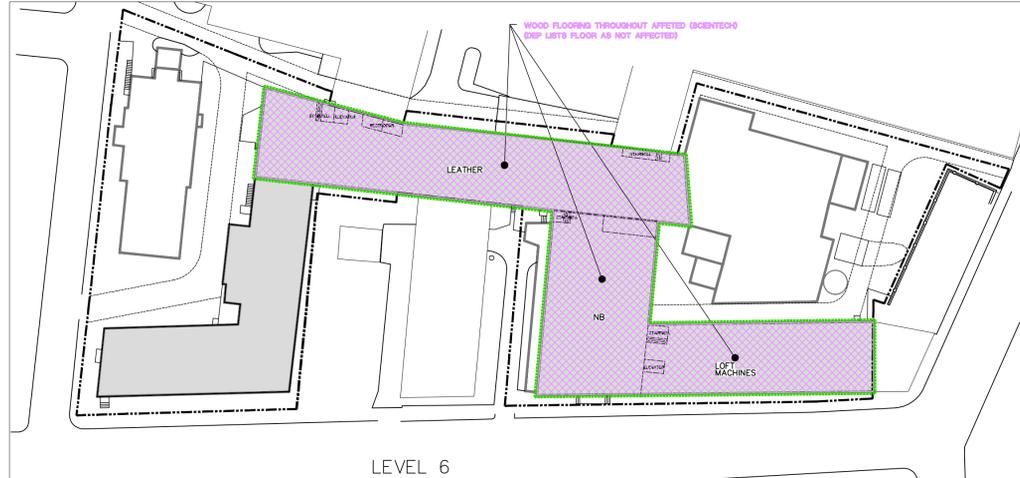
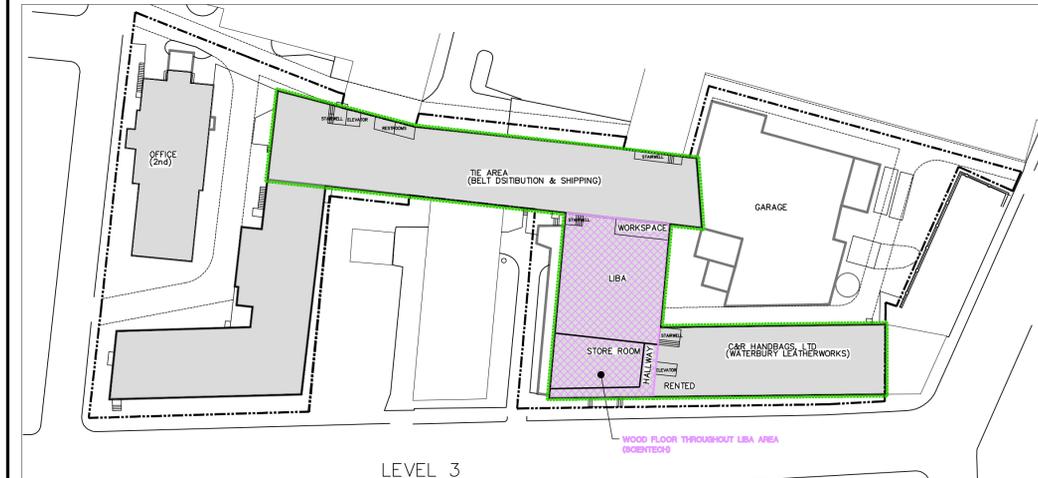
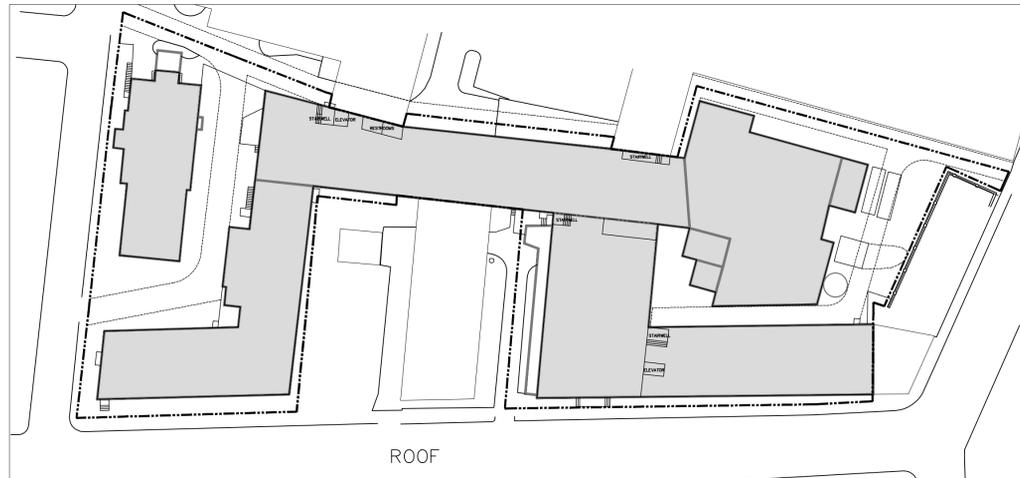
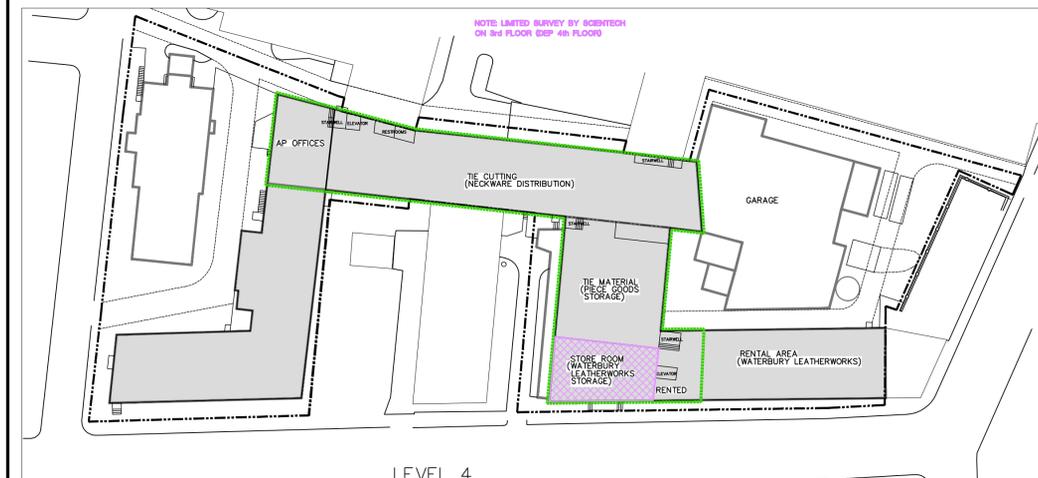
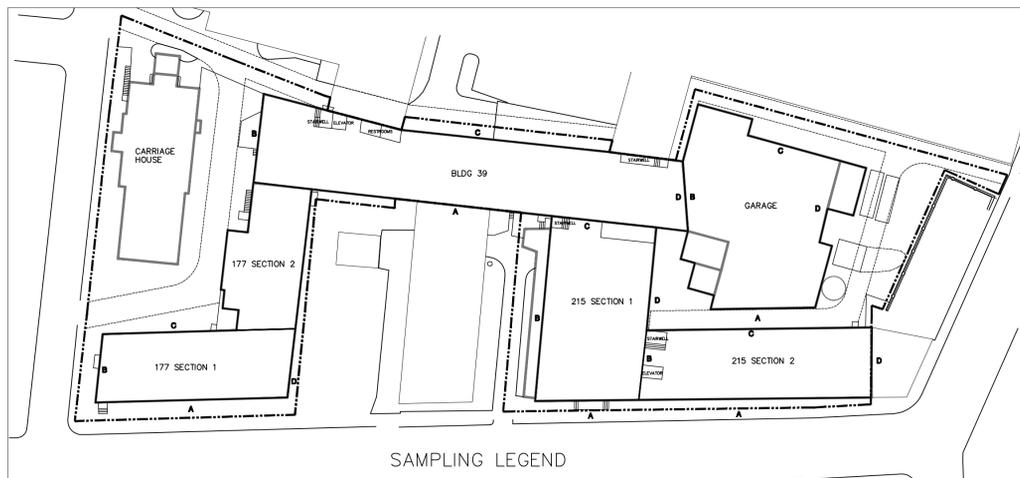
DRAWING

The attached drawing, Drawing 1, depicts generalized areas of known radium contamination in purple hatching; these areas were identified based on written or photographic evidence of radium contamination noted in previous radium survey data and reports. This data was compiled to provide a general understanding of the locations of radium contamination and potential radium for the purposes of health and safety and

At the request of CTDEP, no building material samples were collected from areas known to be subject to radium contamination, as noted from survey data on the attached drawing. The locations of radium-contaminated areas were confirmed by field screening with a Ludlum Model 3 Geiger Counter with a GM 44-9 Pancake Probe. Because sampling was prohibited in these areas, the location and quantities of hazardous buildings materials in these areas were visually assessed and estimated for the purpose of this survey.
